# **GENERAL ASSESSMENT REPORT**

**TOWN OF CUTLER BAY  
EXISTING PARK BUILDINGS  
FRANJO PARK  
20175 FRANJO ROAD  
CUTLER BAY, FLORIDA**

**August 8, 2018**

**Prepared by:  
Ferguson Glasgow Schuster Soto, Inc.**

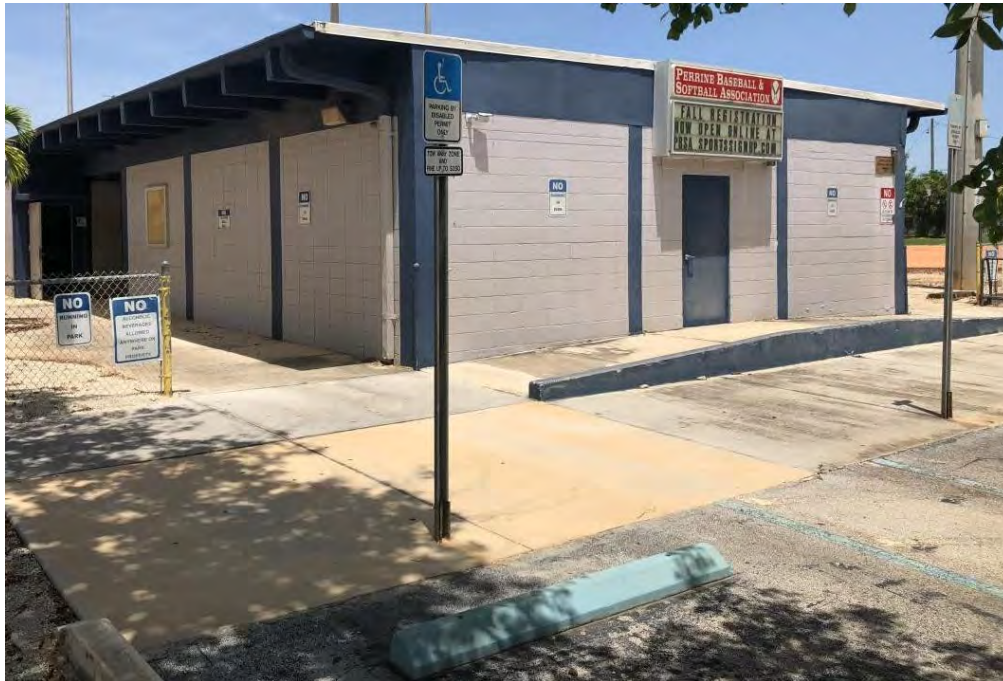
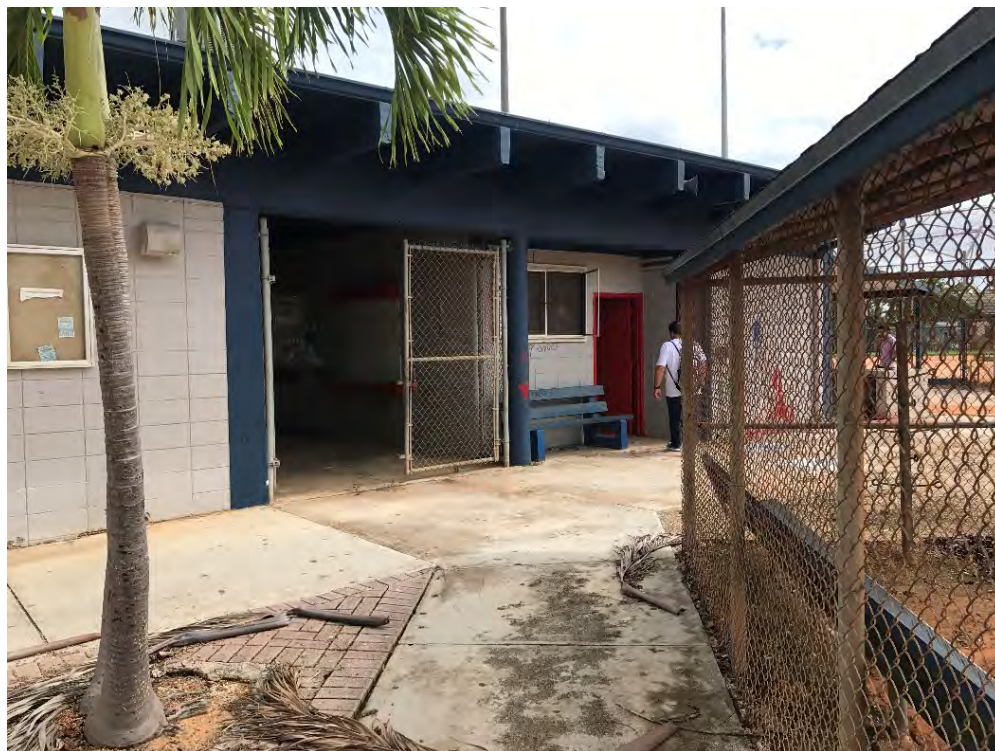
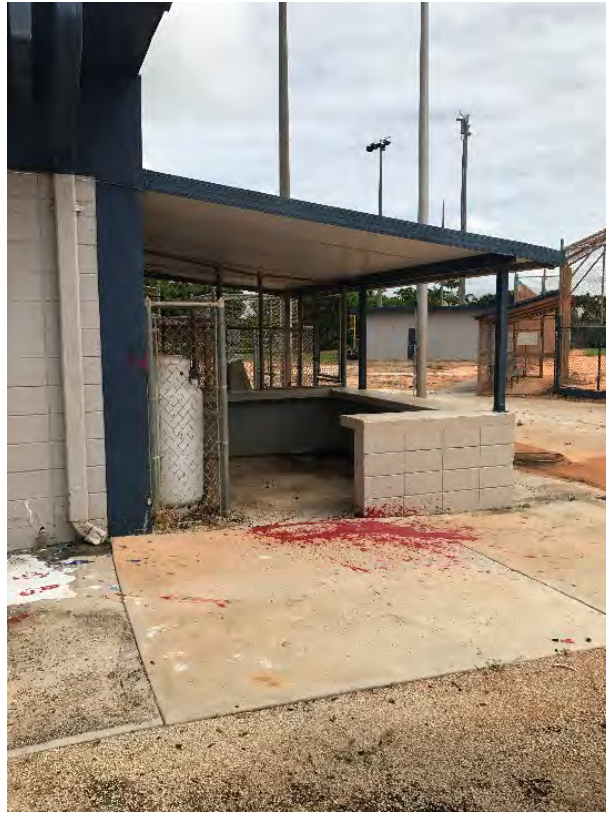
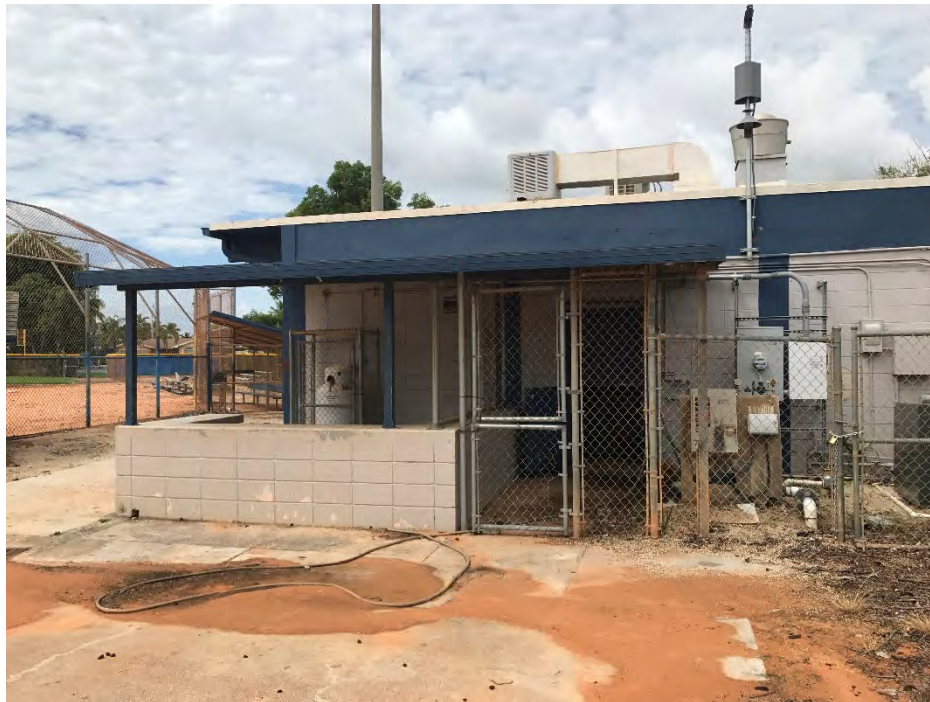
The exterior of the Community Building is in generally good condition (refer to structural portion of the report for additional information not covered in this section). Portions of the building have been vandalized. Recommended repairs include roof flashing, replacement of damaged metal canopy, exterior light fixtures, and all exterior doors are recommended. It is also recommended to remove all obsolete wall and roof mounted equipment, to repair holes and cracks on walls, and re-paint the entire building. No clear indication was found through a permit history search that the roof has been replaced. Built-up roofing has an average life expectancy of 15 years. Indications of past leaks were found in bathroom area. It is recommended that the buildings are re-roofed following the removal of obsolete roofing mounted equipment. Refer to accessibility portion of the report for additional recommendations stemming from accessibility non-compliance.

(Refer to image 1, 2, 3 & 4)

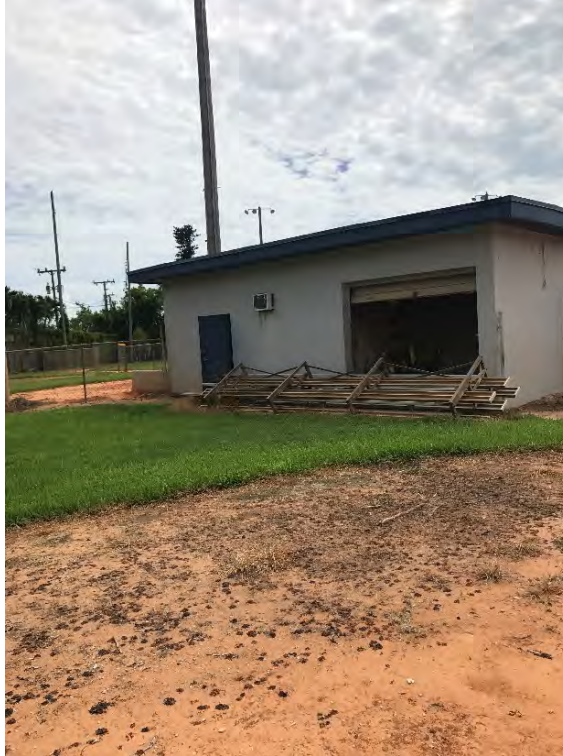
**LOCKER ROOM BUILDING PHOTOGRAPH NO. 5**

Site work project should address access to locker room by providing a paved walkway to the entrance. Building should be reconfigured to best fit the use of the Town of Cutler Bay. During reconfiguration, damaged wood partitions should be removed and replaced throughout the building. Damaged roof joists should be repaired. A new ceiling should be added to the entire building with new insulation in the cavity between the ceiling and the roof structure. Exterior walls should be insulated and finished. New lighting and an A/C system should be installed for the locker room areas. Bathroom facilities are suggested to be installed inside the locker rooms. All exterior doors and hardware should be replaced. (Refer to image 5). Refer to structural portion of the report for additional recommendations.

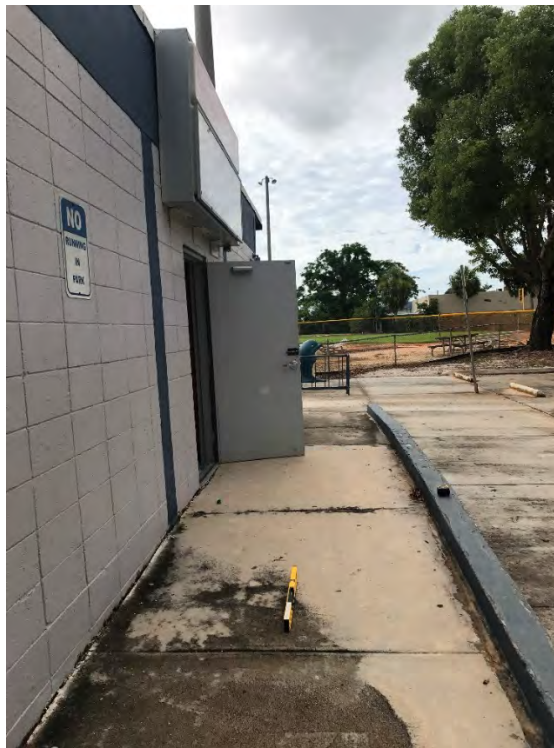
**EXTERIOR RAMP PHOTOGRAPH NO. 6**

The main entrance to the community building is served by a ramp on the Northwest corner of the building and a sloped walkway on the Southwest corner which meet at the landing for the entrance. (Refer to image 6)

The ramp, walkway, and landing dimensions, running slopes, and cross-slopes were found to be in compliance with Accessibility requirements. Due to the ramp having a rise higher than 6 inches into the main entrance door, the addition of handrails on both sides is required.

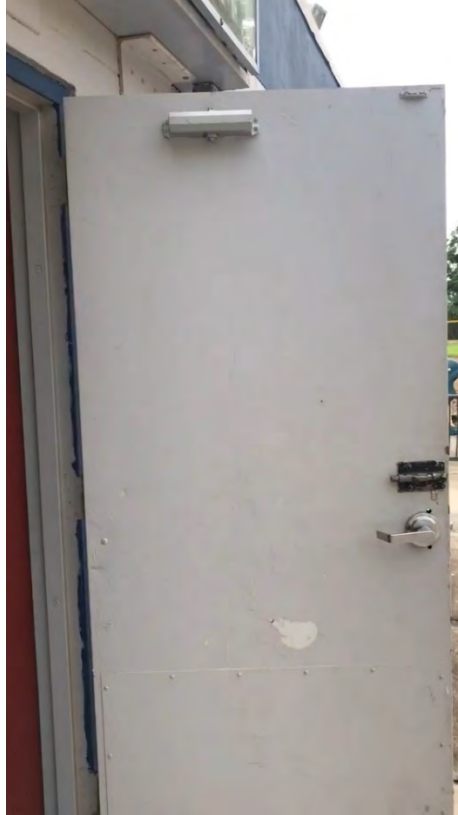
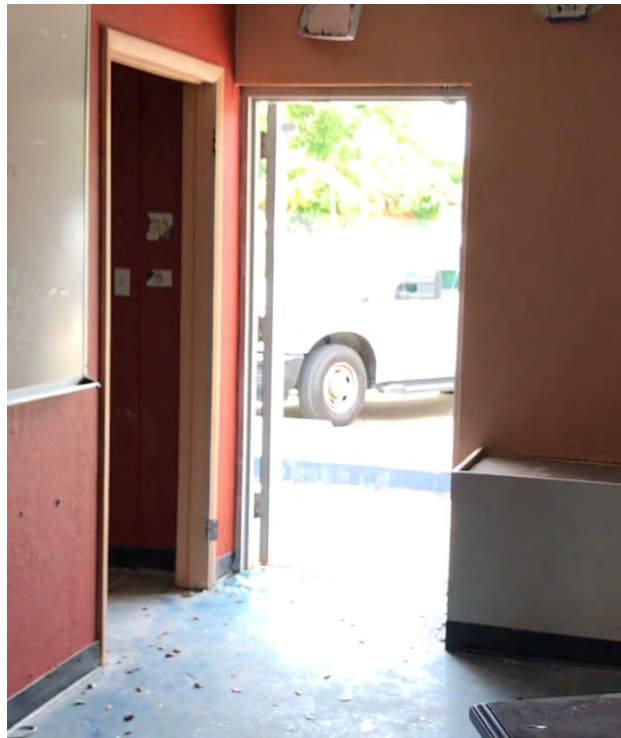
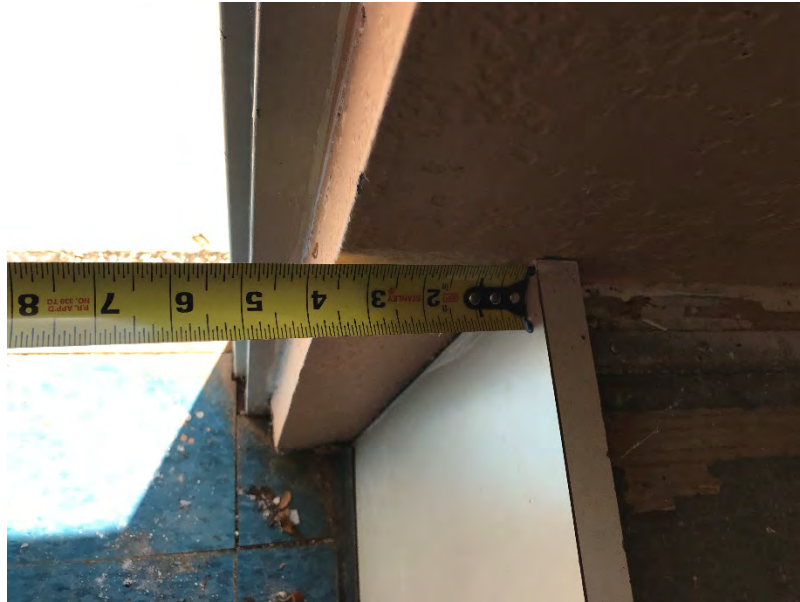
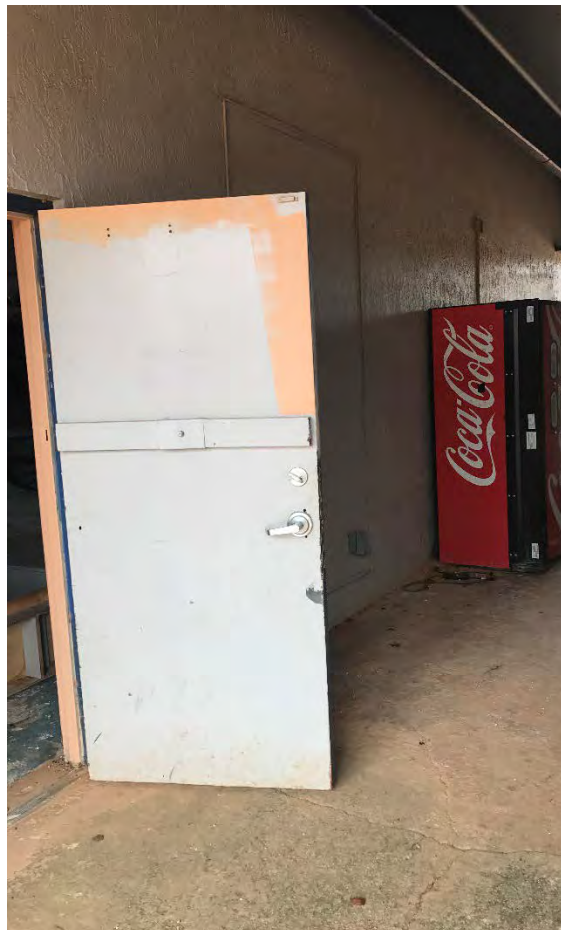
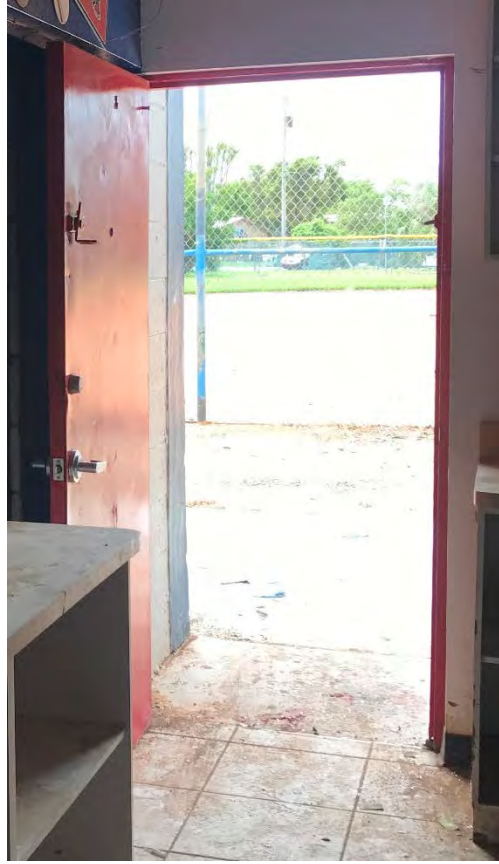
Entrances to the community building, food prep area, and restrooms building are hollow metal doors. The closers on the doors were found to be non-operational in the food prep and community room portions of the building. The restroom doors will be covered in a separate portion of the report.

Hollow metal doors heavily damaged from years of use and should be replaced along with the frames, hardware, and closers. Currently, conflicts with existing built-in seating/storage area and A/C closet do not allow for required push side clearance at either of the entrance doors to the community building. Closers were found to be non-operational. Reconfiguration of the program and spaces to accommodate new program for the Town of Cutler bay should take into account the required push/pull clearances, door pressures, and closing speed at the accessible entrances. (Refer to images 7, 8, 9, 10 & 11)

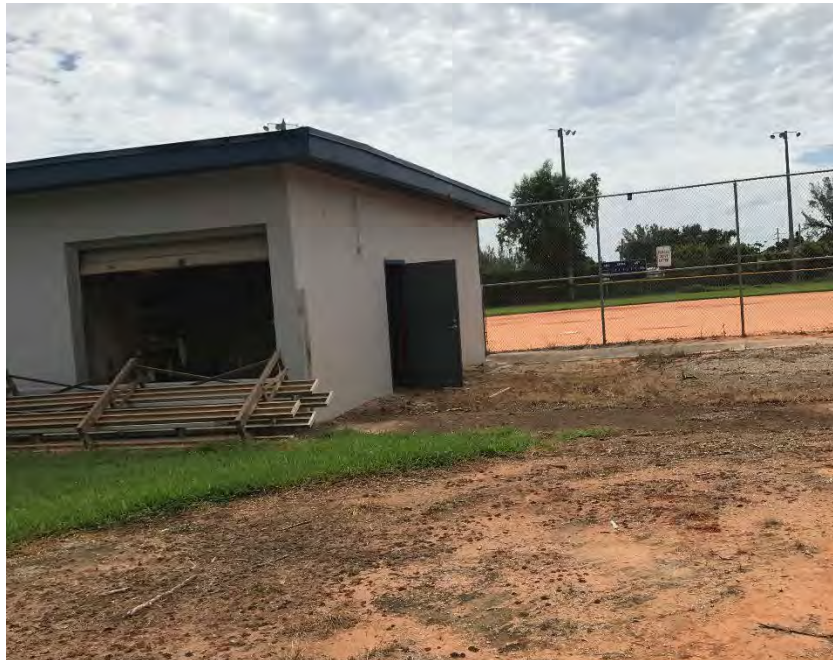
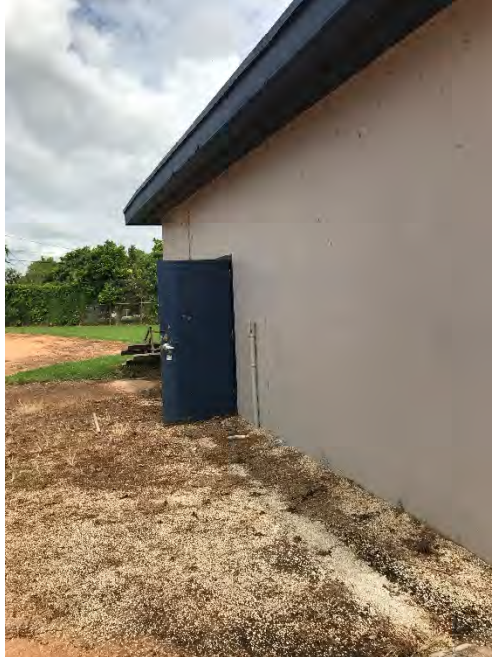
Access to the Locker Room building from the parking lot is via a series of concrete walkways outside of the scope of this investigation. Both entrances to the locker room portion of the building are over grass and uncompacted clay. (Refer to images 12 & 13)

Accessibility guidelines require that the route be stable, firm, and slip resistant. At least one accessible route should be provided connecting accessible buildings.

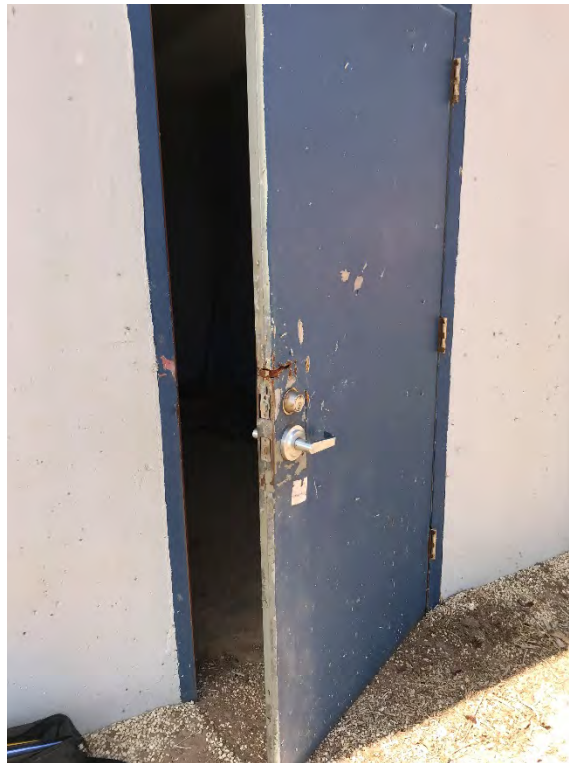
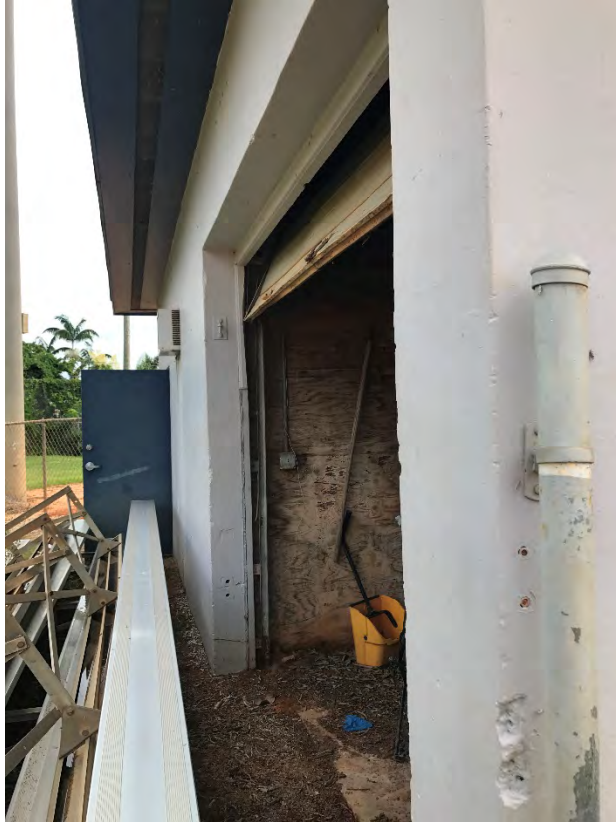
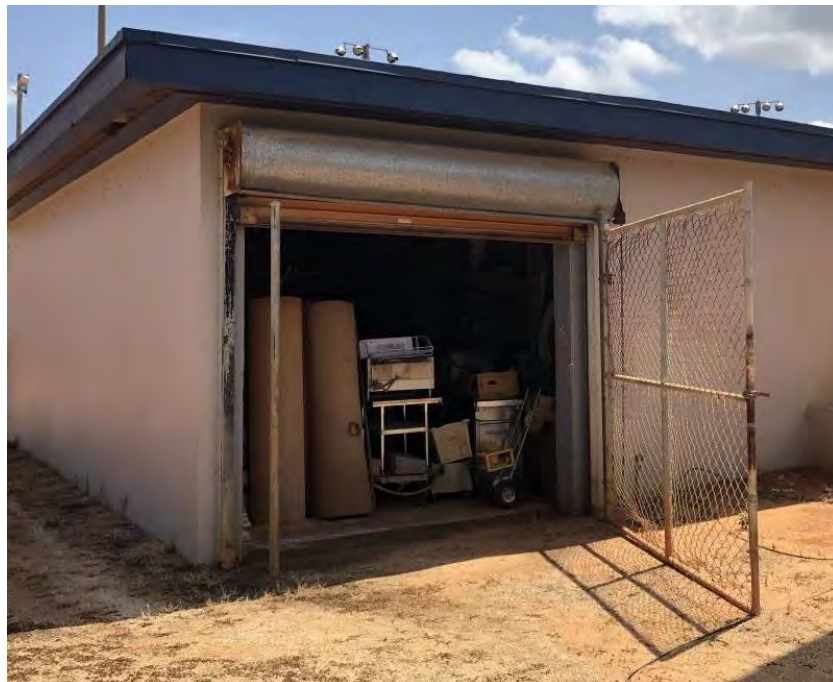
Entrances to the locker room portion of the building are thru hollow metal doors. The closers on the doors were found to be non-operational. Storage areas are accessed through roll-up doors. No accessible entrance to these areas exist. (Refer to images 14, 15 & 16)

Hollow metal doors and roll-up doors are heavily damaged from years of use and should be replaced along with the frames, hardware, and closers. Reconfiguration of the storage spaces to accommodate new program for the Town of Cutler bay should take into account the required push/pull clearances, door pressures, and closing speed at the accessible entrances.

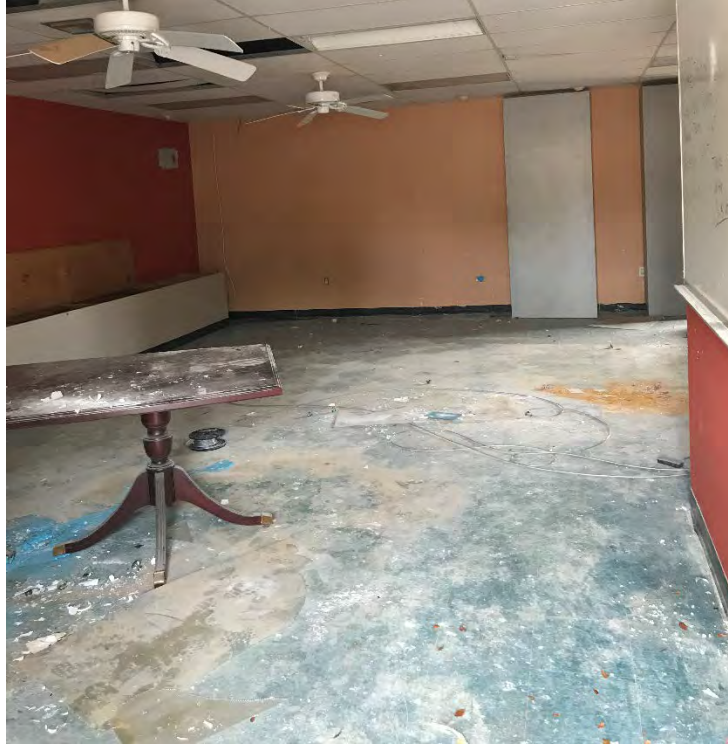
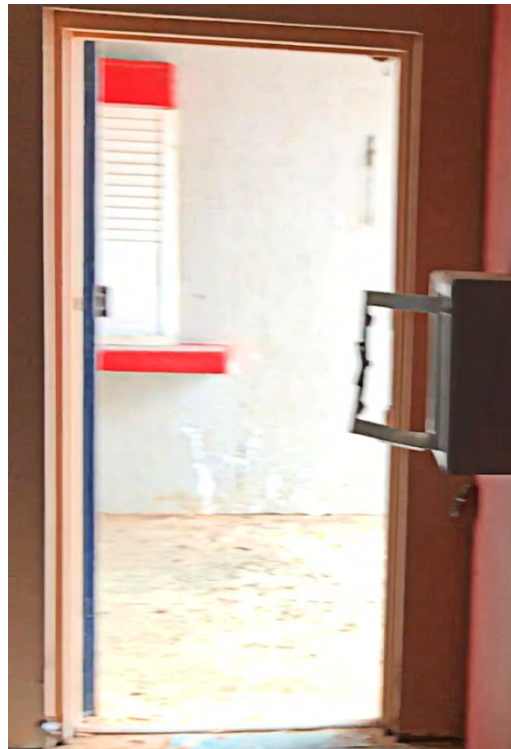
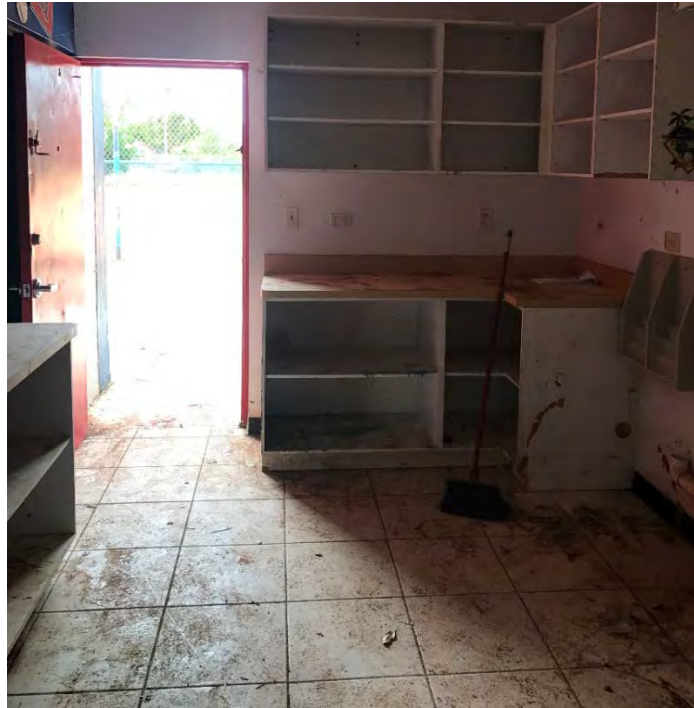
Community space is composed of VCT over a concrete slab. Flooring for food prep and kitchen areas are ceramic tile. Wall mounted cabinets containing fire extinguisher and AED Equipment were found installed in the accessible route and were found to have been vandalized. (Refer to images 17, 18 & 19)

Various tiles are lifted and/or have been damaged. VCT in the building should be replaced to provide a firm and slip resistant accessible route. Tile in food prep and kitchen areas are heavily soiled with oily residue and should be thoroughly cleaned to provide a firm a slip-resistant surface. Various wall mounted cabinets, new cabinets for AED equipment and fire extinguishers should be installed in a manner & location compliant with ADA. Opening from food prep area to cooking/kitchen area is does not have the required width clearance due to built-in shelving intruding into the opening. Built-in shelving reducing the width of the opening into the kitchen should be removed. (Refer to image 20)

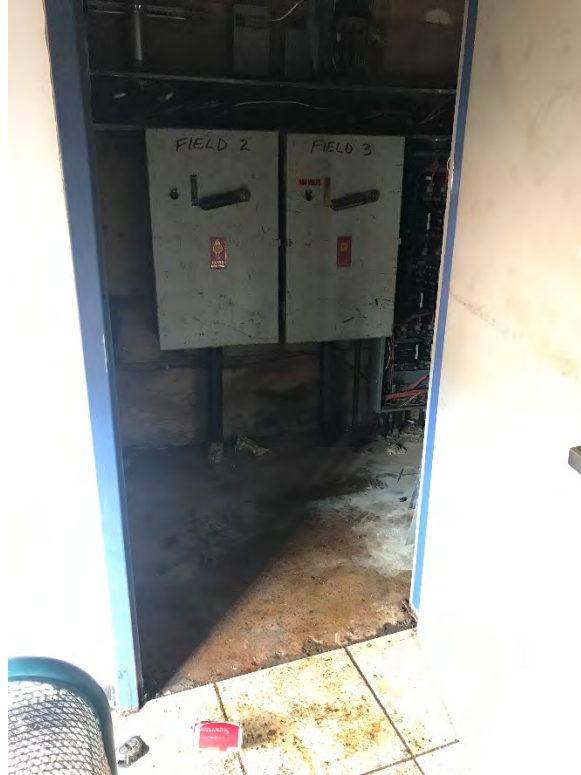
ELECTRICAL ROOM ENTRANCE PHOTOGRAPH NO. 21

Doors to the administrative office, storage area, and mechanical/electrical room were noted missing. Exterior doors are covered in a separate portion of the report. (Refer to image 21)

There is a missing door to the administrative area that swings out and encroaches into the clear space required on the push side of the main entrance door. Reconfiguration of the program and spaces to accommodate new program for the Town of Cutler bay should take into account the required push/pull clearances, door pressures, and closing speed at the accessible entrances.

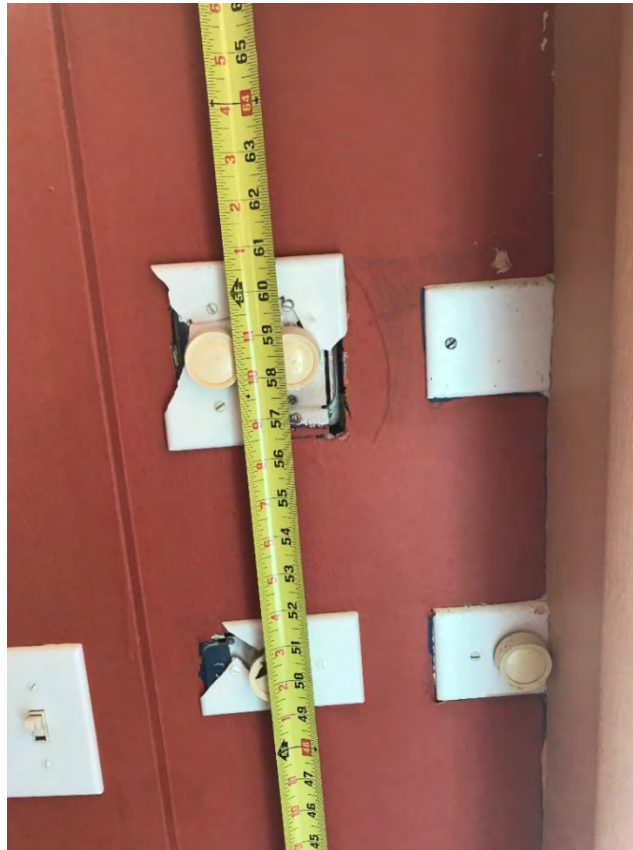
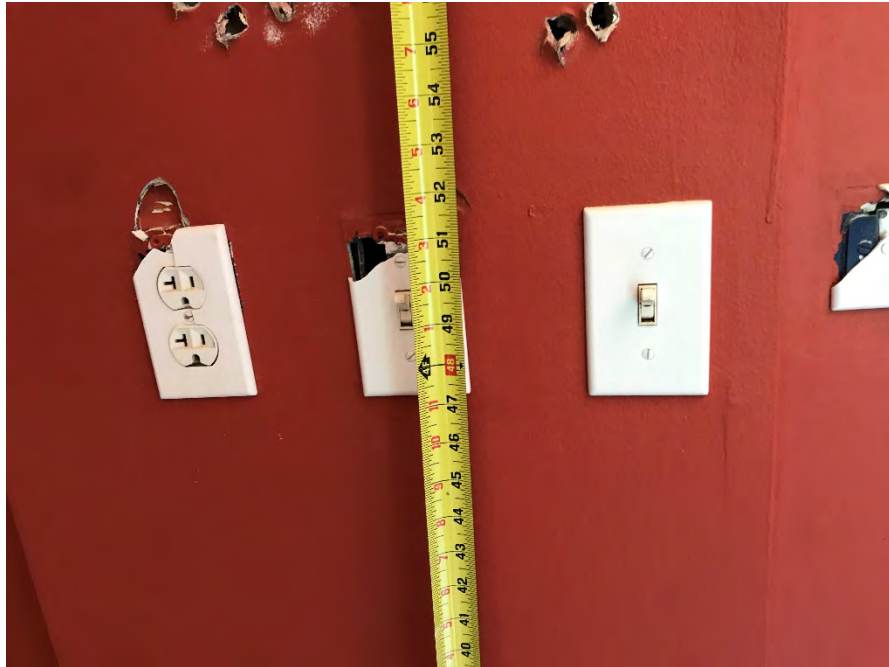
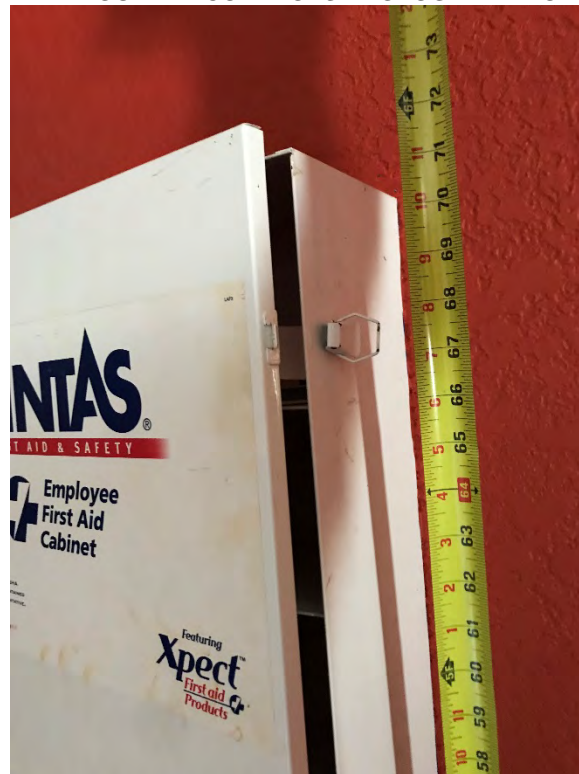
Controls for equipment, general lighting, and fire suppression are wall mounted throughout the Community Building. The field lighting controls are mounted in the food preparation area adjacent to the electrical panels. (Refer to images 22, 23 & 24)

Various light switches and field lighting controls were found to be mounted higher than what accessibility regulations allow. New work on the building should take into account the relocation of these non-compliant items. Controls that require grasping, pinching, or twisting of the wrist should be replaced.

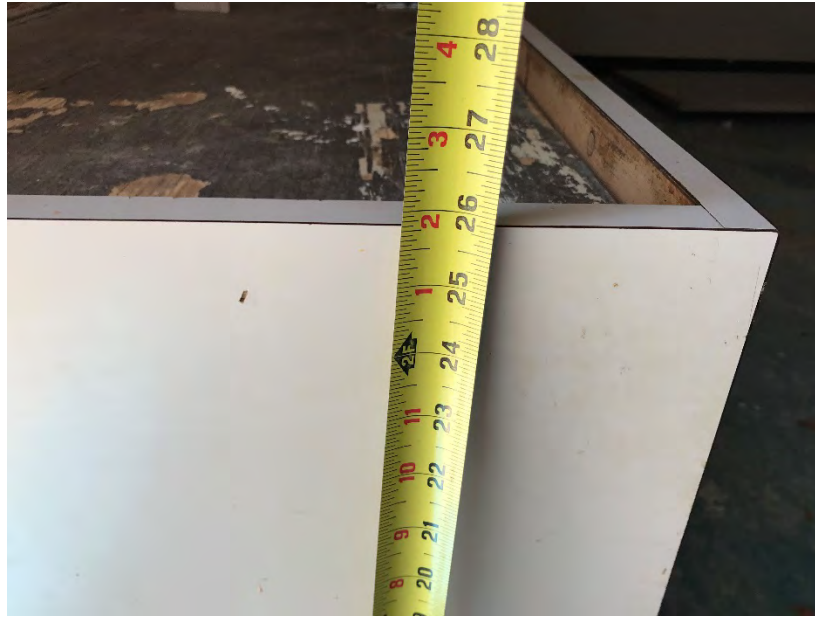
COMMUNITY BUILDING BUILT-IN BENCH PHOTOGRAPH NO. 25

A combination of seating and storage was found in the community room lining the west and north exterior walls. (Refer to image 25)

Bench seating lining exterior walls was found to be encroaching into the push side clearance of one of the exterior doors. The height for the bench exceeds the maximum height above the finish floor required for accessibility. Bench integrity was questionable at the time of the walk-through. Built-in benching should be removed. If City of Cutler Bay desires to have built-in seating/storage, new ADA compliant seating/storage should be provided.

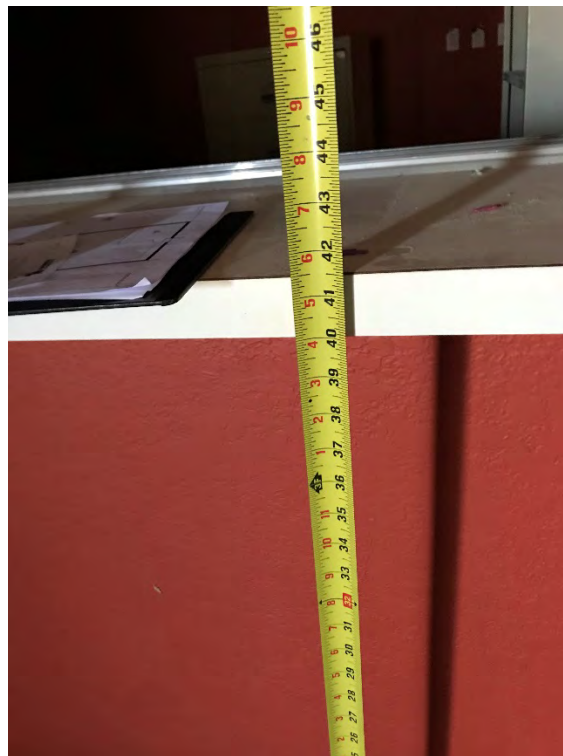
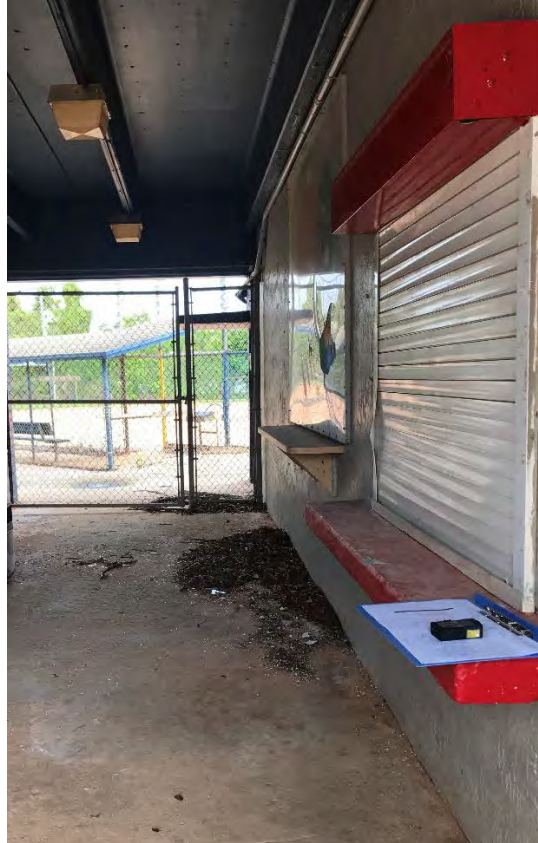
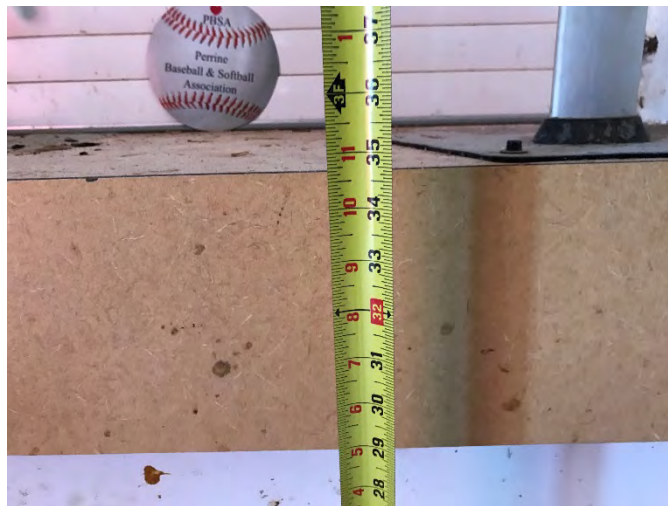
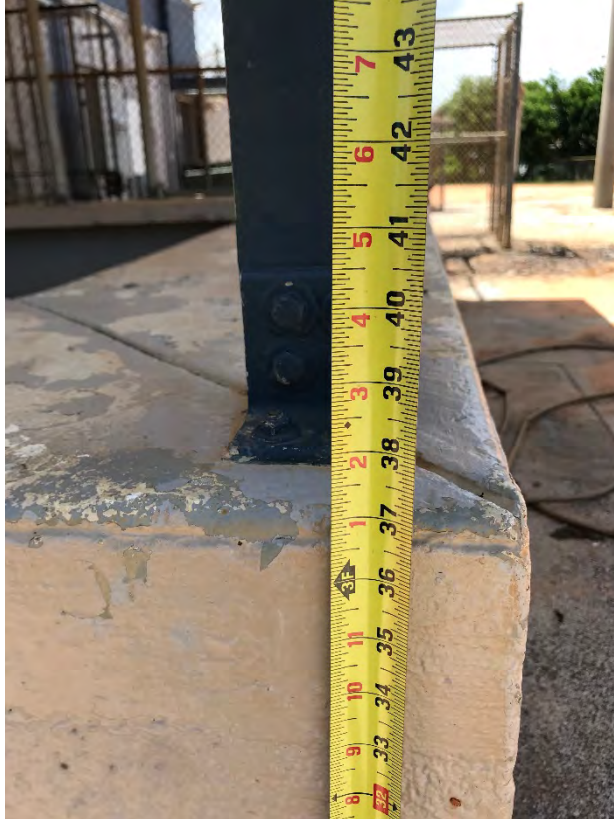
Multiple service counters were surveyed. A walk-up service counter was found in the community room. A second built-in service counter was noted in the food prep/kitchen area. A third service counter was found under the east-facing exterior metal canopy. (Refer to images 26, 27, 28 & 29)

Height of community room service counter was found to exceed allowable accessible height. Portions of the exterior concrete service counter were found exceeding the allowable accessible height. Reconfiguration of the program and spaces to accommodate new program for the Town of Cutler bay should take into account

providing the required accessible counter space at both non-compliant areas. Work on exterior walkways outside of this assessment's scope of work should be coordinated so that exterior walkways are raised to provide an accessible service counter in lieu of removing or rebuilding the exterior concrete counter.

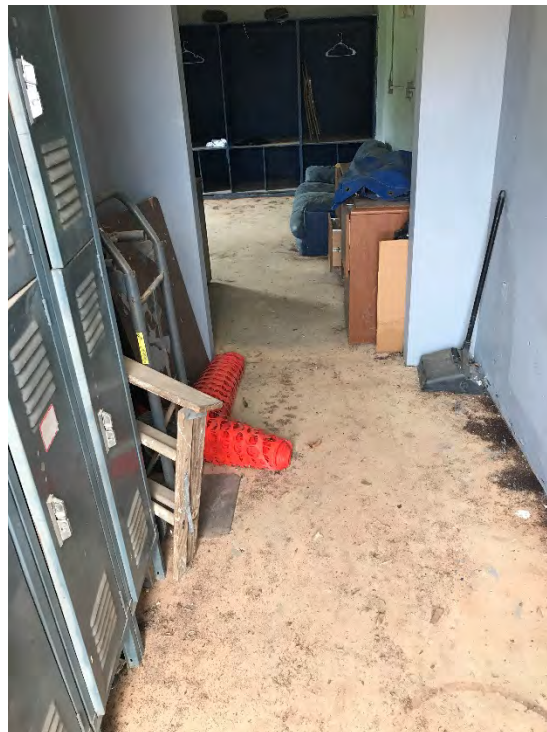
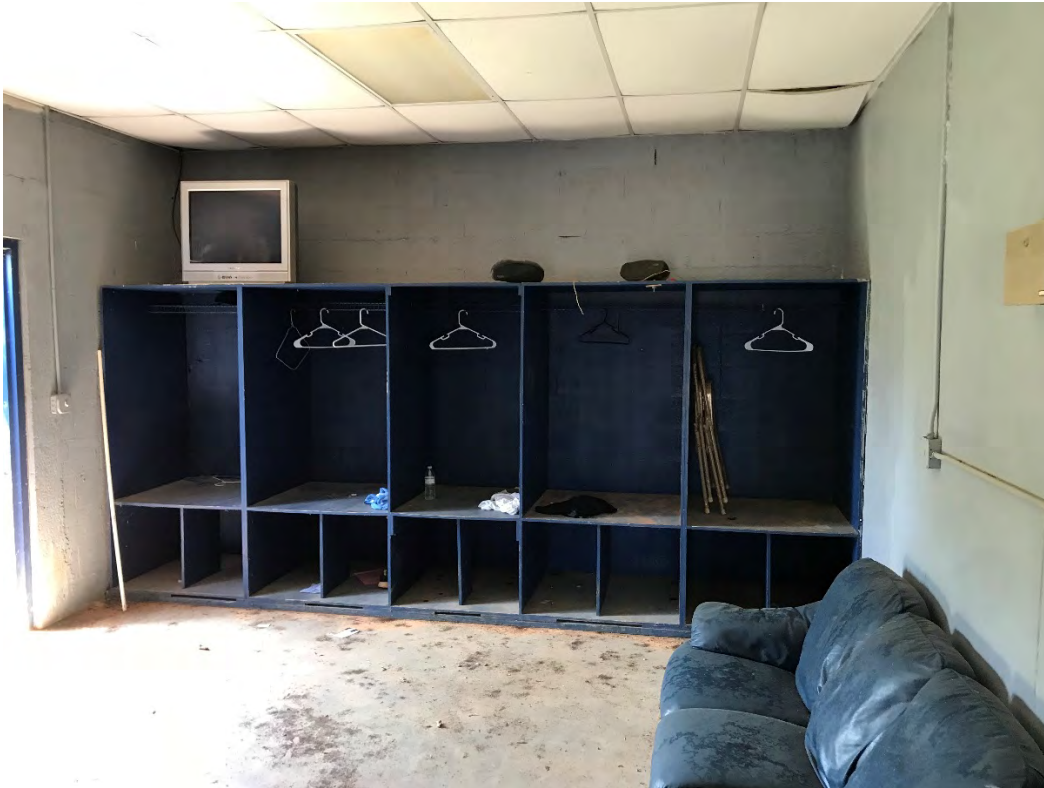
Locker room and storage areas flooring visible during walk-through were noted to be exposed concrete slab. Various furniture items and equipment are placed throughout accessible routes reducing the path widths and clearances. (Refer to images 30 & 31)

Reconfiguration of the program and spaces to accommodate new program for the Town of Cutler bay should take into account proper flooring finish selection, built-in casework and furniture placement. New recessed fire extinguisher cabinets are recommended to be installed in lieu of bracket mounted fire extinguisher to remove protruding objects into the accessible route.

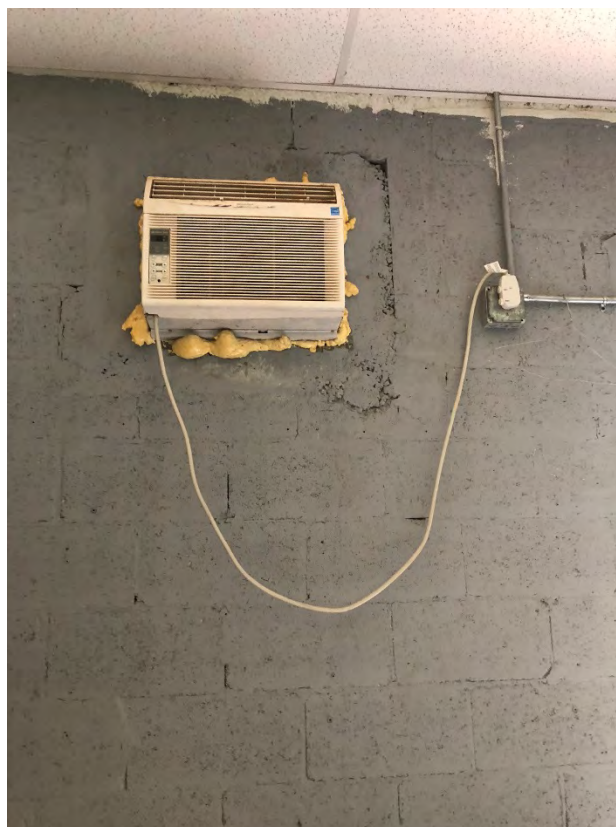
**LOCKER ROOM BUILDING A/C SYSTEM PHOTOGRAPH NO. 32**

Various light switches, outlets, and controls were found to be mounted higher than what accessibility regulations allow or inaccessible due to the content of the storage area. New work on the building should take into account the relocation of these non-compliant items including wall mounted A/C system. Controls that require grasping, pinching, or twisting of the wrist should be replaced. (Refer to image 32)

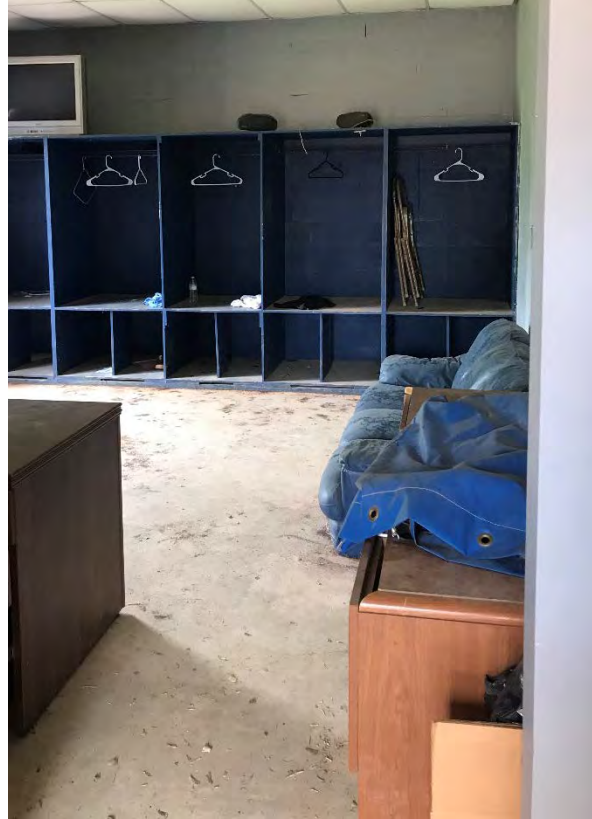
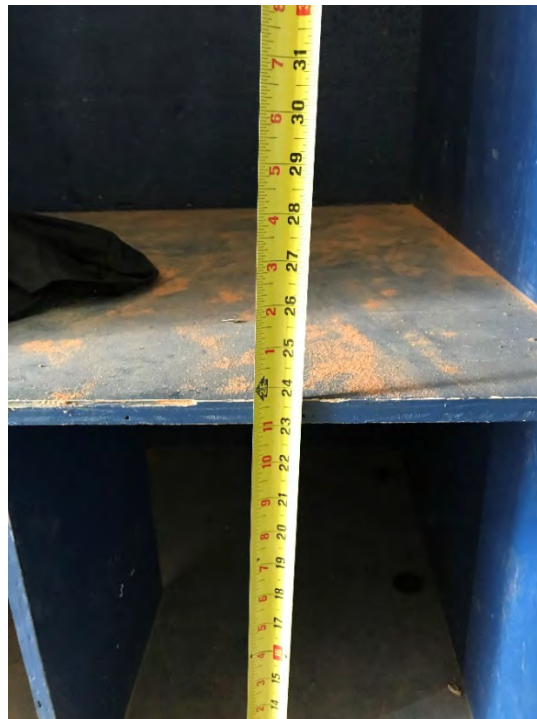
Benches built into the lockers were noted in locker room portion of the building. (Refer to images 33 & 34)

Bench seating in locker room not in compliance with accessibility requirements in the following categories: Bench depth and height exceed required allowed dimensions. Bench width does not provide sufficient width. No clear space parallel to the short axis of the bench. Built-in locker stalls and benches were also found to be damaged by wood eating insects and by the elements. It is recommended that these be replaced with ADAAG compliant lockers and benches.

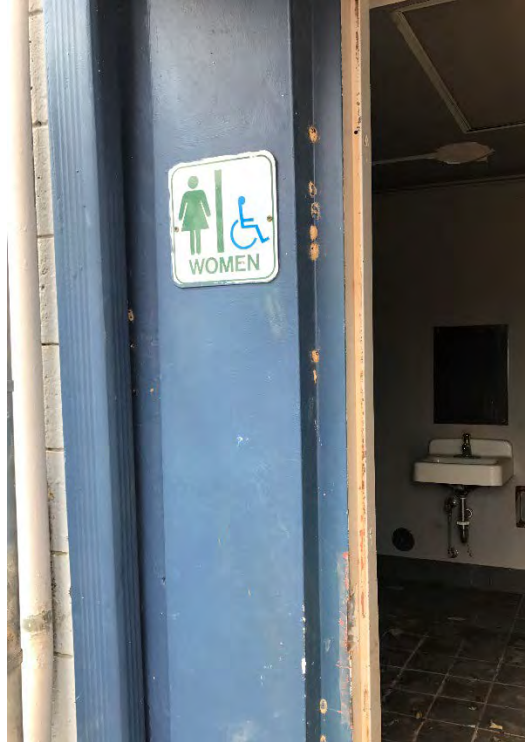
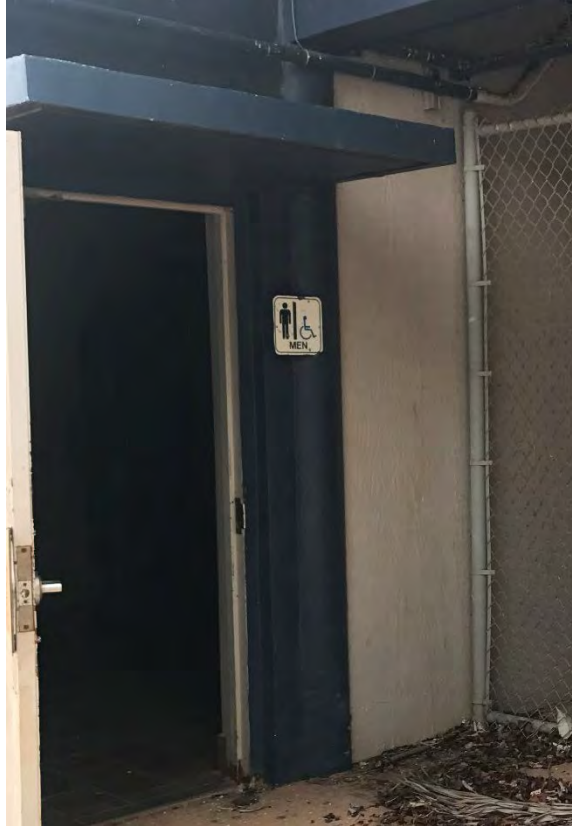
Permanent signage is installed at the latch-side of each of the toilet rooms' entrances. (Refer to images 35 & 41)

Signage installed does not meet Accessibility requirements and should be replaced with new signage including raised characters contrasting with signage background and shall include braille. New signage shall be mounted at with the highest tactile character at no higher than 60 inches above the finished floor.

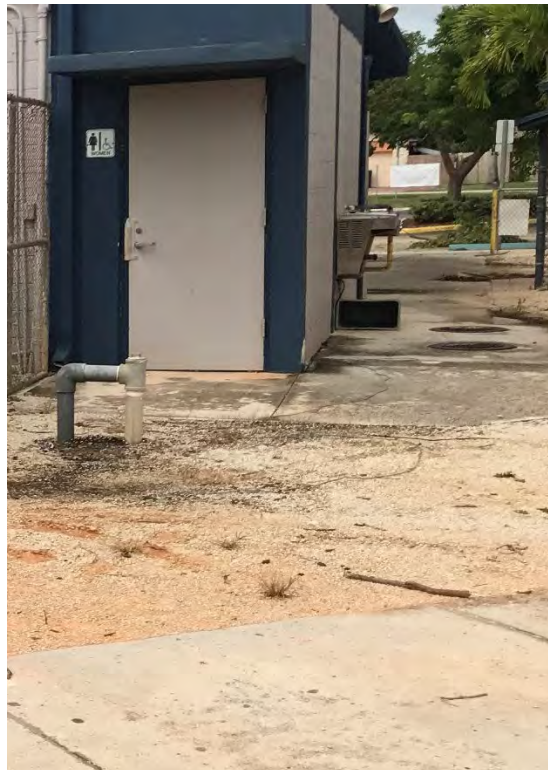
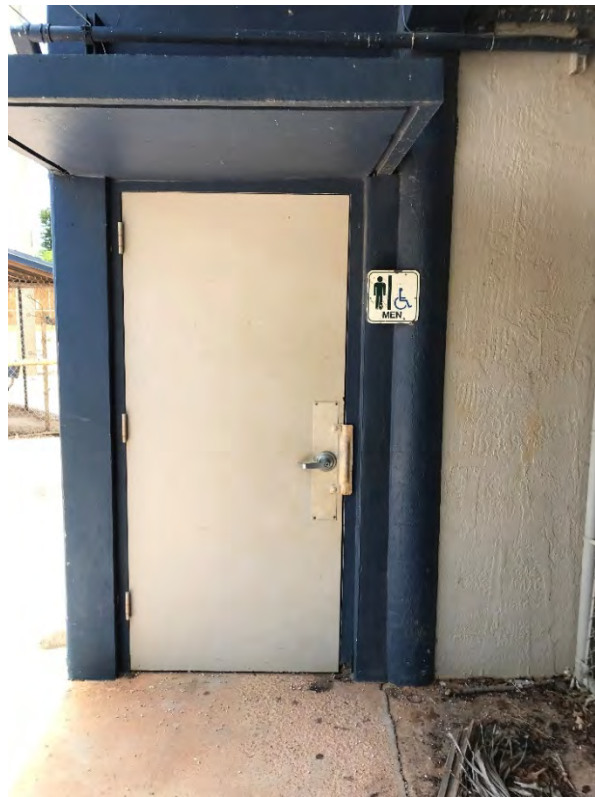
A single hollow metal door is existing at each of the restrooms. Exterior restroom doors were noted to have closers, lever style hardware, and do not have thresholds. (Refer to images 36 & 42)

Exterior doors we found to be in working order but should be replaced due to their advanced age. No indication of impact-resistant rating was found during the walk-through. Should the Town of Cutler Bay decide that doors should remain at each of the restrooms, the existing closers should be adjusted to meet the pressures required to open the door and the closing speed. ADA compliant thresholds should be installed in order to reduce the amount of outside water entering into the restrooms.
