# **GENERAL ASSESSMENT REPORT**

**TOWN OF CUTLER BAY  
EXISTING PARK BUILDINGS  
FRANJO PARK  
20175 FRANJO ROAD  
CUTLER BAY, FLORIDA**

**August 8, 2018**

**Prepared by:  
Ferguson Glasgow Schuster Soto, Inc.**

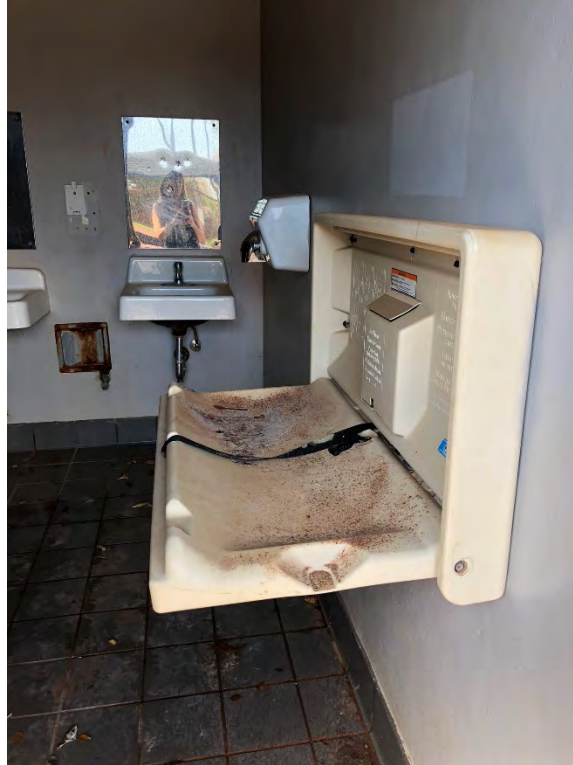
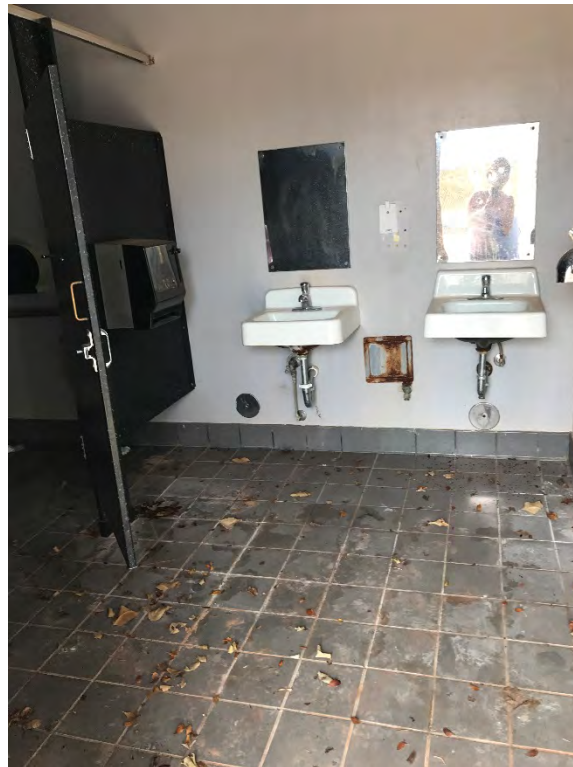
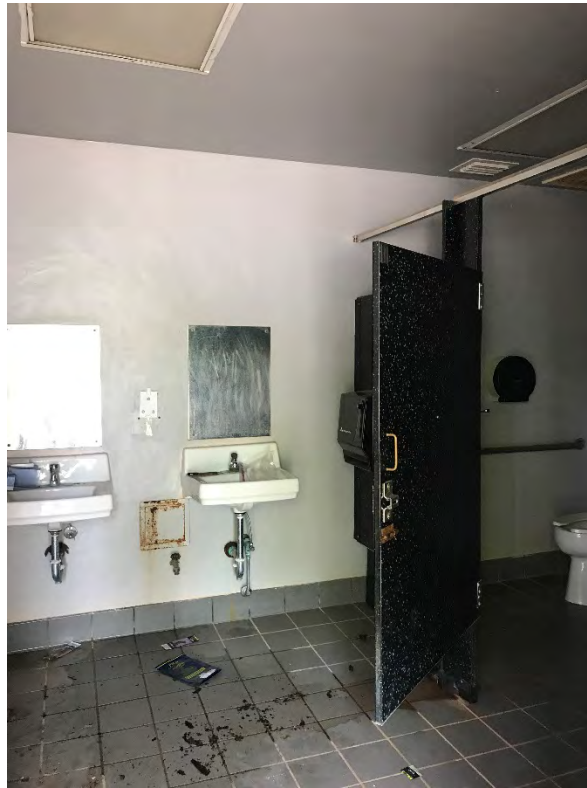
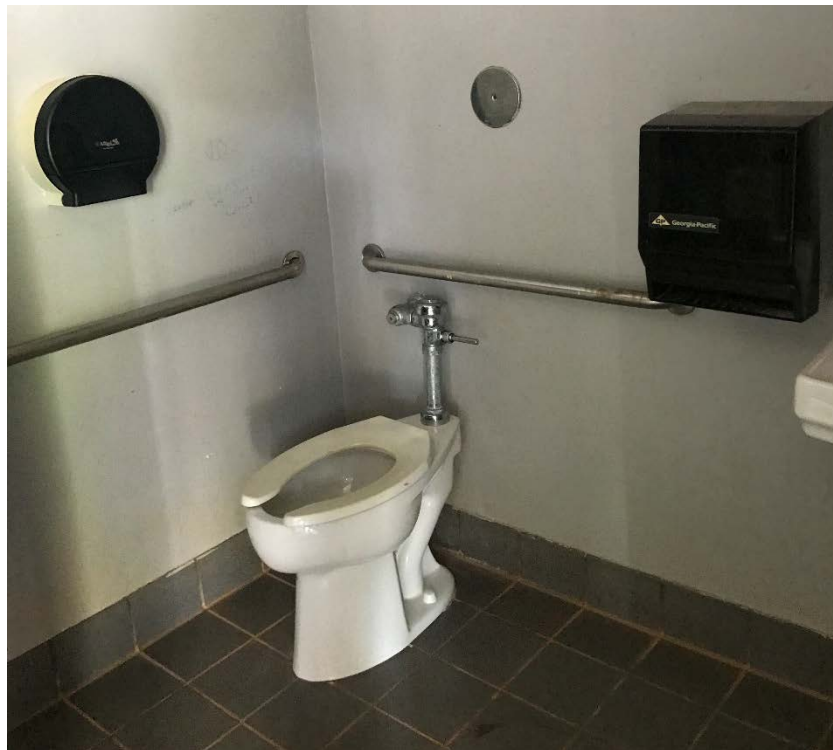
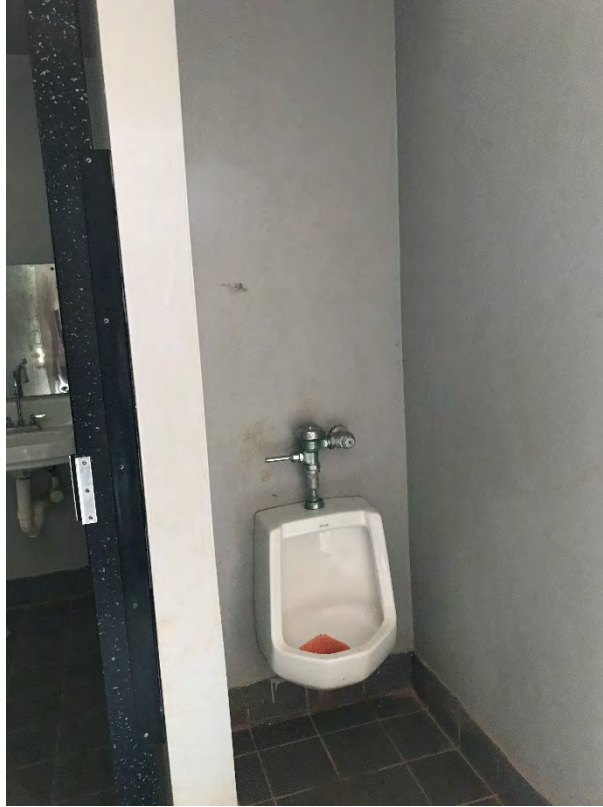
Male restroom fixtures consist of one urinal, one accessible toilet stall with sink, and two sinks outside of the accessible stall. Female restroom fixtures consist of a toilet stall, an accessible toilet stall with sink, and two sinks outside of the accessible stall. There are hose bibs in each of the restrooms. (Refer to images 37, 38, 43, 44 & 45)

Accessible clearances around Female and female restroom toilets were found to be non-compliant due to the sink encroaching into the toilet clear space. Accessible urinal in male restroom was found not to have the required clearance for wheelchair use. It is recommended that both restrooms are reconfigured to allow for required ADA clearances. Sinks in restrooms were found to have rust and showing early stages of deterioration. It is recommended that the 6 sinks in both restrooms are replaced. Existing hose bibs were found rusty and prone to vandalism. It is recommended that they be replaced with tamper-proof hose bibs.

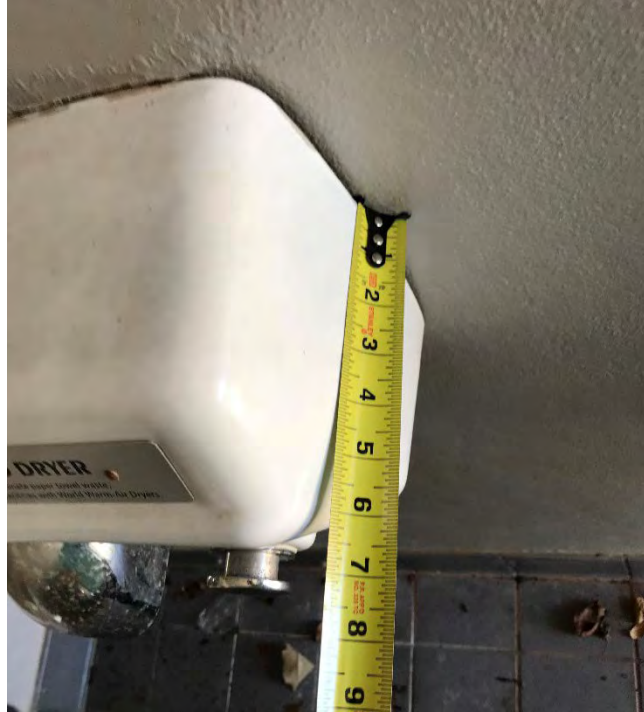
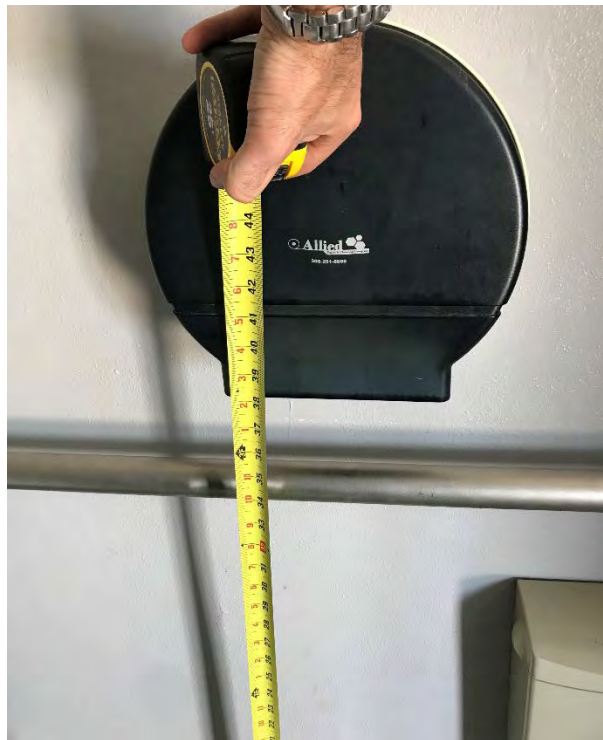
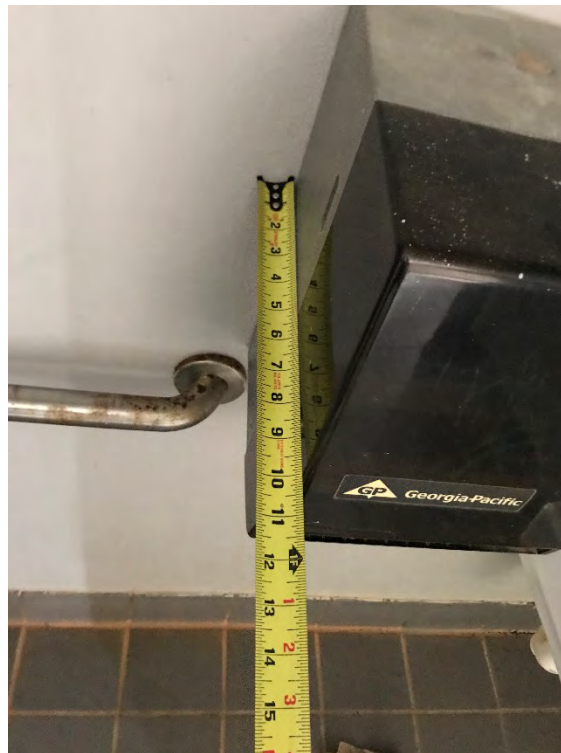
Accessories in toilet rooms include paper towel dispensers, baby changing stations, electric hand dryers, grab bars, soap dispensers, toilet partitions, sanitary napkin disposal, wall mounted mirrors, and coat hooks. Various access panels are existing on bathroom walls and ceilings. (Refer to images 37, 39, 40, 44 & 46)

When open, the baby changing station in the female restroom encroaches into the bathroom door entrance's clear floor space. When bathroom is reconfigured, the baby changing station shall be placed in a location not conflicting with accessible clear floor space. New baby changing station should be added to male restroom.

Existing hand dryers, paper towel dispensers, and toilet paper dispensers exceed the maximum dimension protruding from the wall to comply with ADAAG. Paper towel dispensers as installed, block access to full use of grab bar in accessible toilet stall. When bathroom is reconfigured, new accessories of compliant depth should be installed.

Side wall grab bars do not extend enough from rear wall in accessible stall. Rear grab placement exceed allowed distance from side wall. Grab bars are showing signs of corrosion and should be replaced.

Multiple soap dispensers were found to have been ripped off the walls. New soap dispensers serving each of the sinks to be installed.

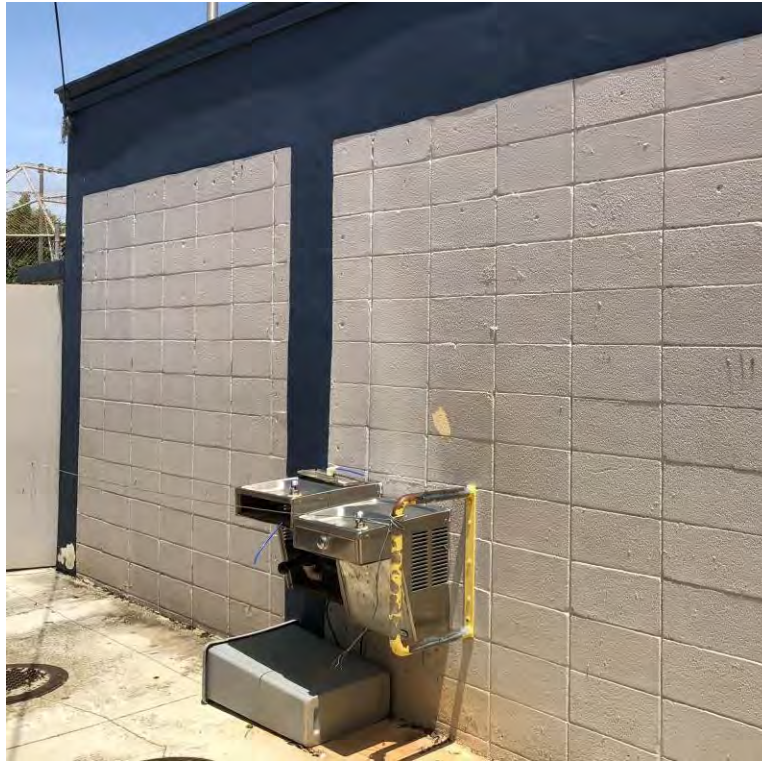
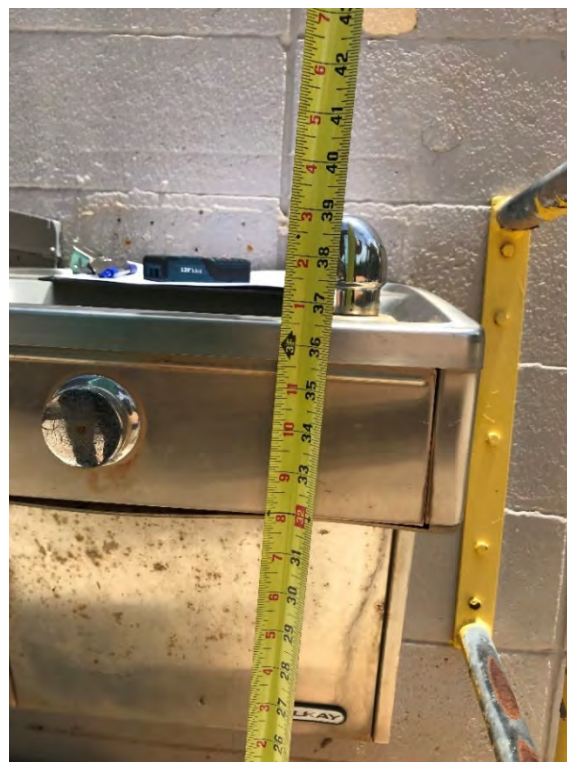
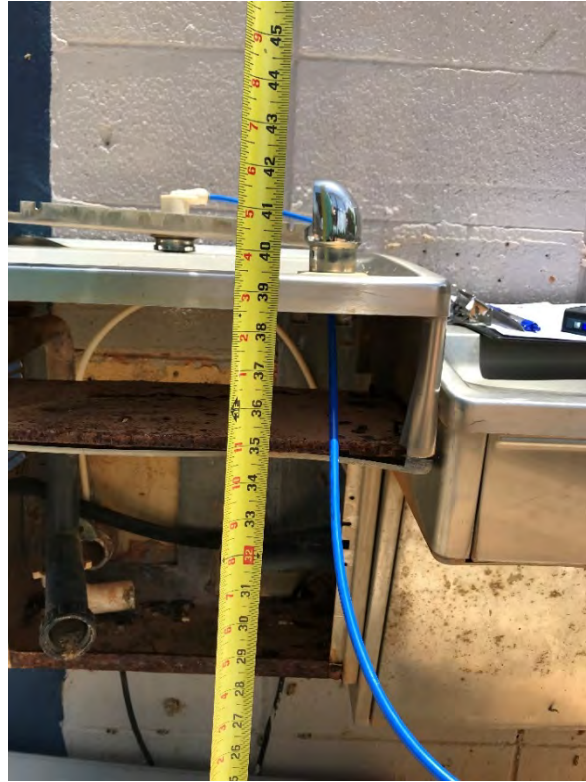
Bi-level existing water drinking fountains are located on the north side of the community center. The drinking fountains were found to be non-operational with significant damage. (Refer to images 47, 48 & 49)

Water fountains frequented by the public must be accessible to both individuals who use wheelchairs and individuals who have difficulty bending or stooping. The spout height for the lower drinking fountain does not comply with minimum height requirements. The leading edge of the fountain is higher than 27" and protrudes more than 4" into the circulation path. Provide bi-level drinking fountains in compliance with ADA standards.
